Image Diagnosis: Foot Fractures

Gus M Garmel, MD, FACEP, FAAEM

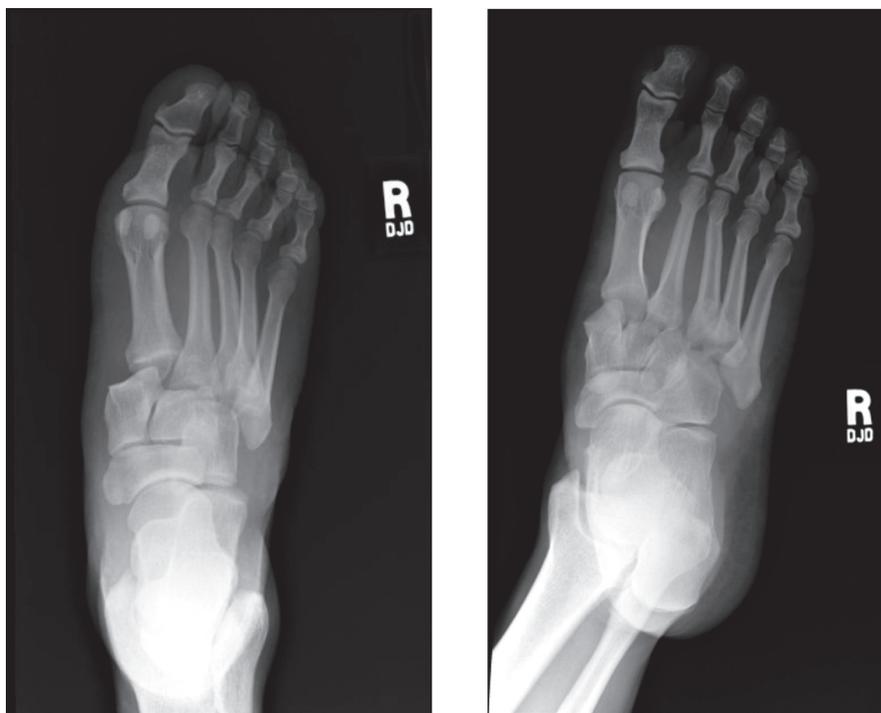
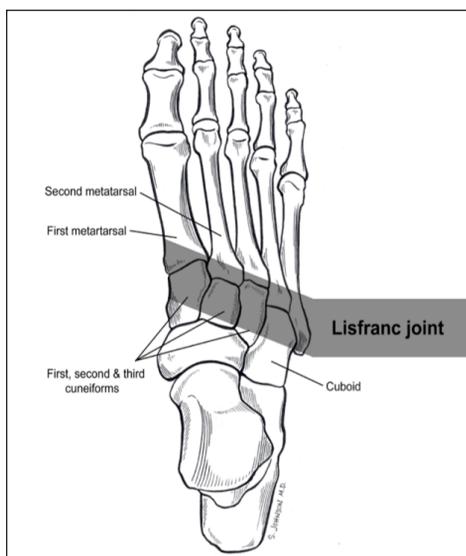
Figure 1. (above, left) Anteroposterior (AP) view of the foot and Figure 2. (above, right) Oblique radiograph of the same foot.

Two views of an injured foot demonstrates disruption of the Lisfranc joint consistent with a Lisfranc fracture-dislocation. Although it is difficult to see a fracture fragment in these films, significant force is needed to disrupt this strong joint which stabilizes the midfoot, often resulting in a fracture at the base of the 2nd metatarsal or one of the cuneiforms. If the diagnosis is in question, a weight-bearing anteroposterior view or a computed tomography scan of the foot may identify this injury. Surgical repair is generally necessary. Compartment syndrome of the foot is a possible complication.

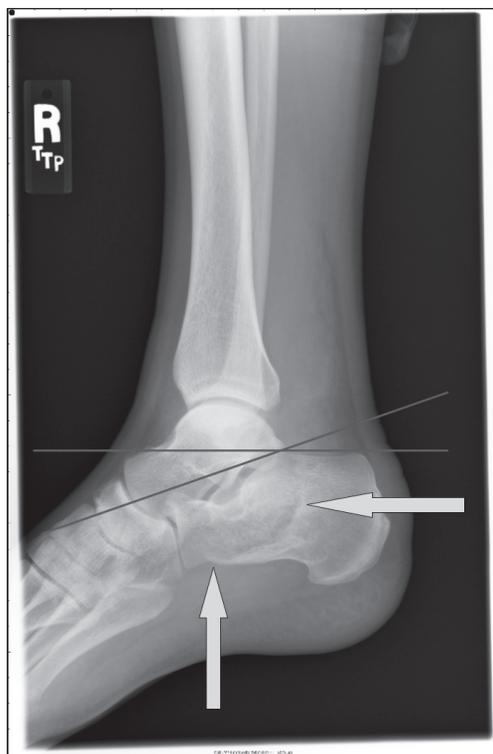
Figure 4. (left) Arrows identify a fracture through the calcaneus.

Angle formed by the intersection of the line connecting the tuberosity and the highest point of the posterior facet with the line connecting the posterior facet and the posterior process of the calcaneus determine Bohler's angle. This angle is normally 20-40 degrees, but can be reduced in some fractures of the calcaneus. In this image, Bohler's angle measures just less than 20 degrees, as this fracture is only minimally displaced.

Clinical Pearl: Calcaneus fractures can be associated with vertebral body fractures of the spine. They carry the eponym "lover's fracture" due to jumping from a height (such as a balcony or second-floor window).

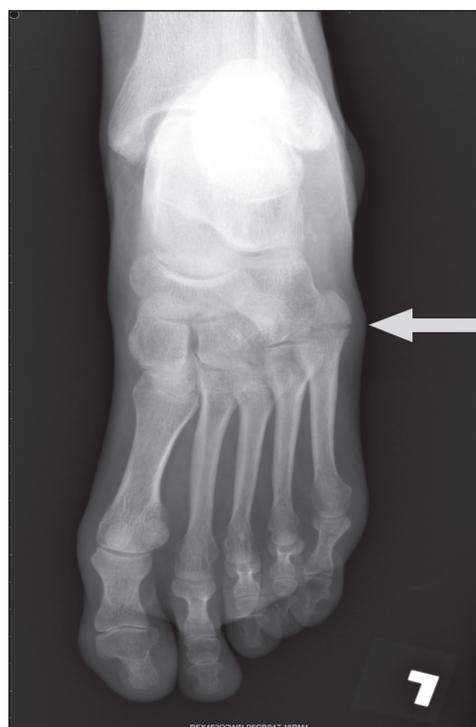
Figure 5. (right) Arrow points to a horizontal fracture line as well as surrounding soft tissue swelling. As this fracture is due to an acute injury, the area of swelling is likely to be tender to palpation.

Jones fracture is due to an acute injury to the lateral midfoot. The fracture line should be located within 1.5 cm distal to the tuberosity of the 5th metatarsal in a horizontal plane. This fracture should not be confused with the more common avulsion fracture at the base of the 5th metatarsal styloid, as treatment differs.
